## ***KM/CS-3050/4050/5050 Firmware Release Notes***

<b>Subject:</b>	<b>Firmware Update</b>
<b>Model</b>	<b>KM/C-3050/4050/5050</b>
<b>Updated Machines Serial Number:</b>	<b>N/A</b>

**The Combined Firmware is updated to Version 2.20C 09/08**

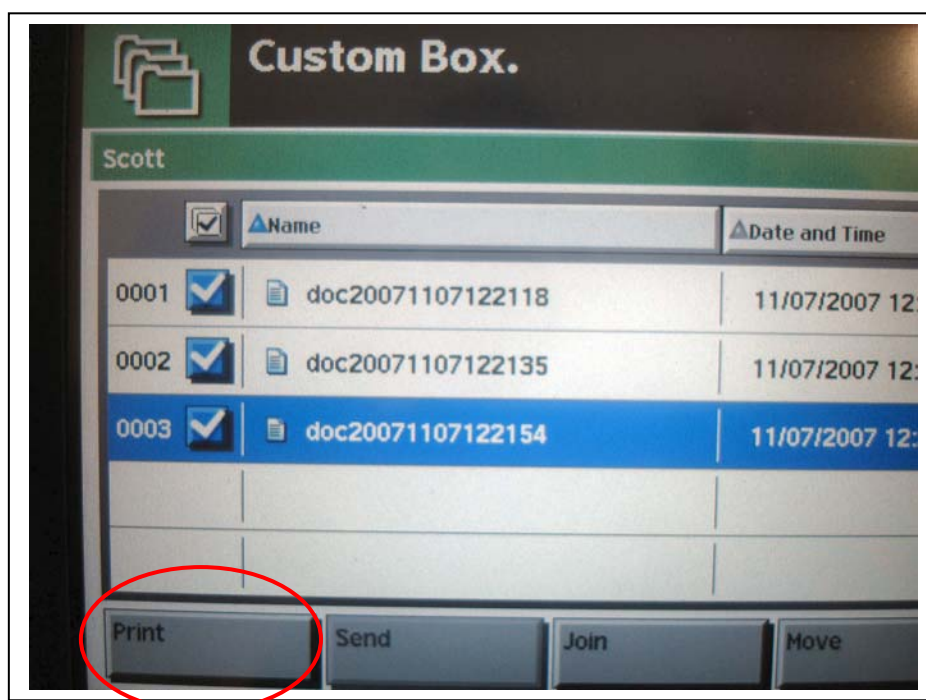
The Print Function is not available when Multiple Documents are selected to Print with previous Firmware.

The example below shows the Print Function is available when Multiple Documents are selected to Print, after upgrading to Version 2.04C Firmware.
